FLEXURAL FIRST PLY FAILURE OF NOTCHED COMPOSITE LAMINATES

B. Adeeko, L. Smith, A. Kothidar,

The School of Mechanical and Materials Engineering, Washington State University

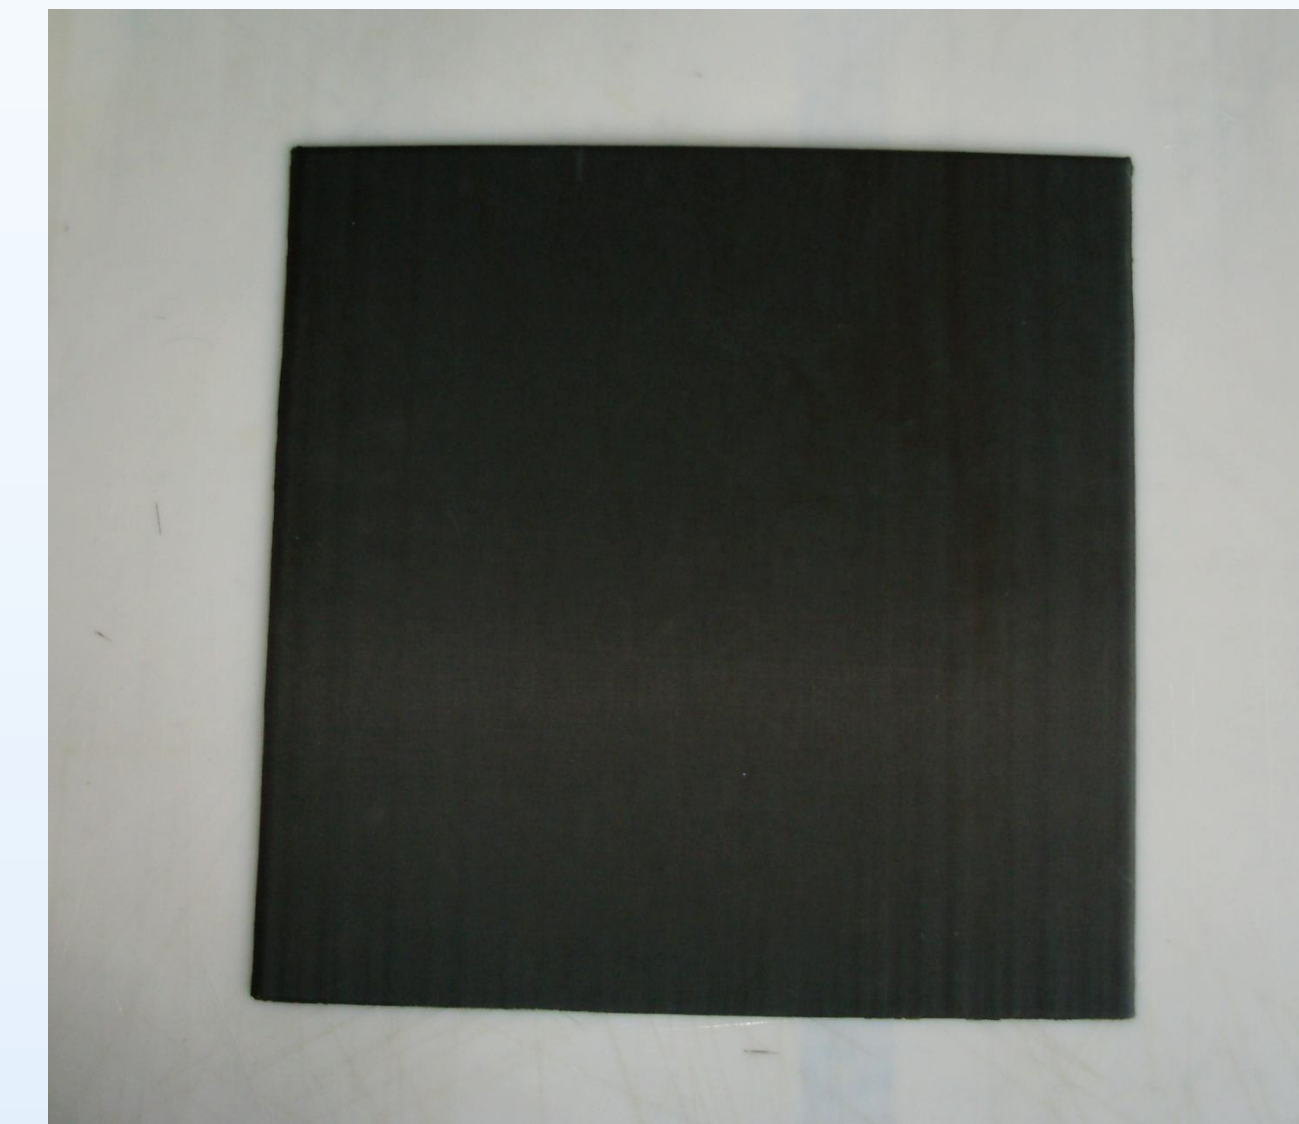
A cured Carbon Epoxy composite plate

The first step in the process is making the coupons. All the coupons tested are sixteen ply, however their ply angles differ. Carbon epoxy sheets are layered onto an aluminum plate and then sealed air tight. The sheet is then cured in an autoclave for several hours.

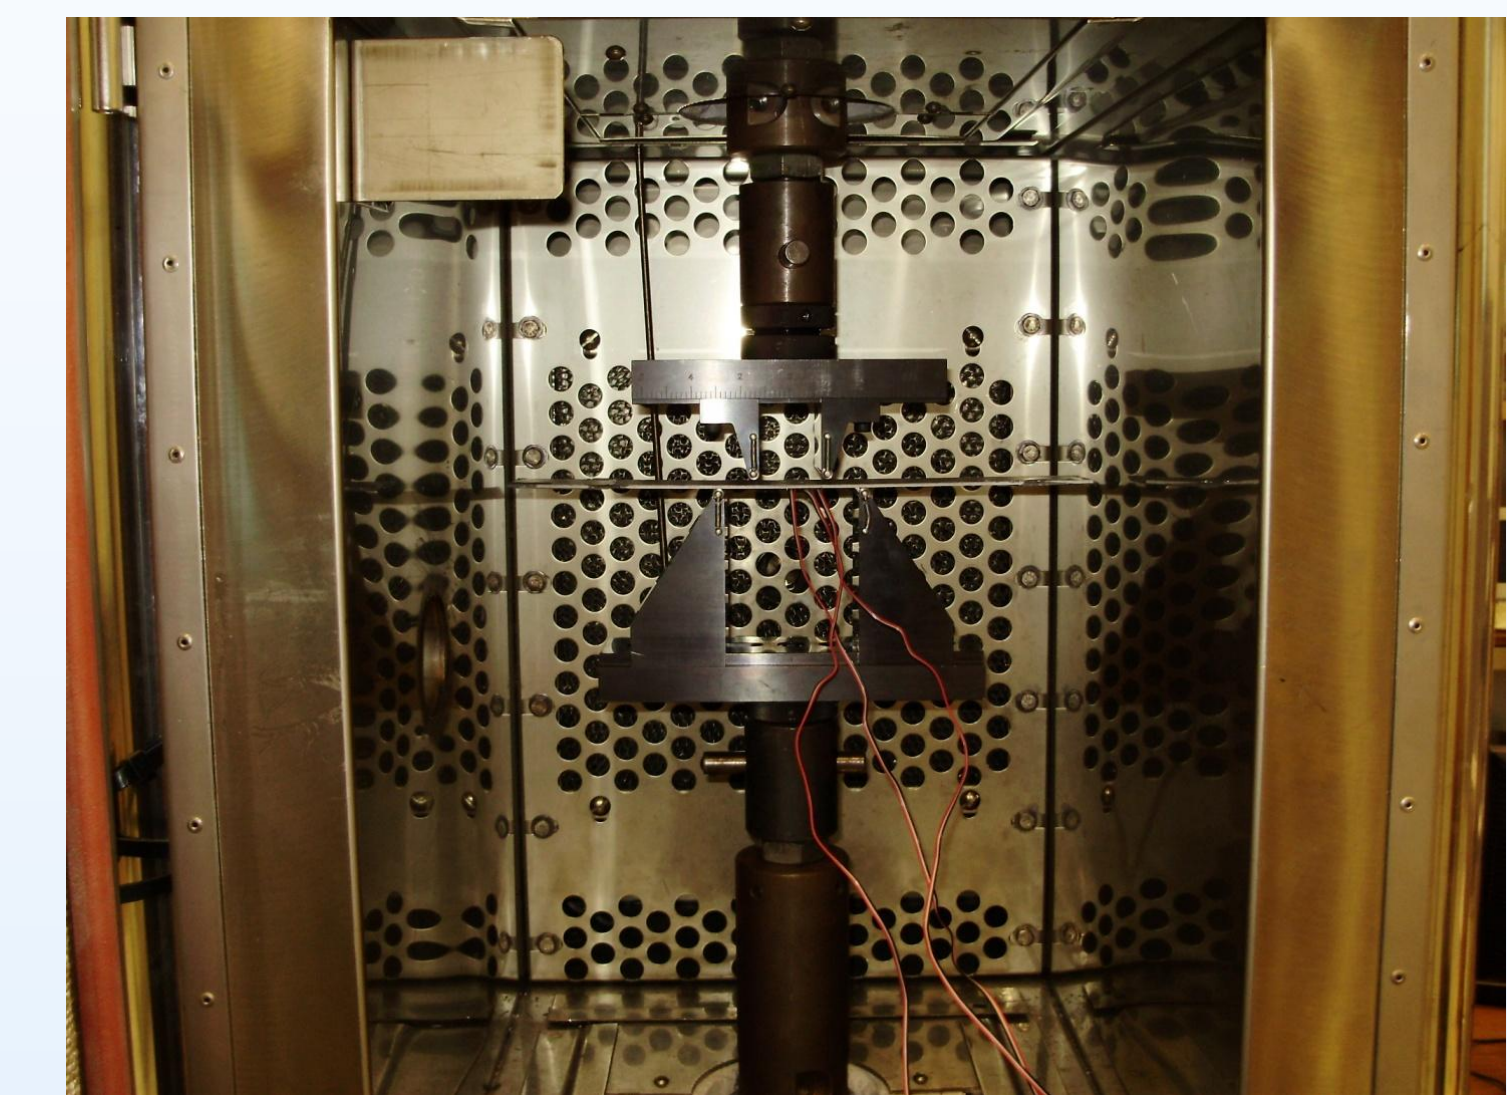
Coupon in the four point flexural setup

The coupons were tested using the four point flexural method. According to ASTM standards the support span is correlated to the depth of the coupons being tested and a certain ratio is then chosen. A span-to-depth ratio of 40 to 1 was chosen for my tests. Subsequently, the load span was one half the support span. The coupons were tested using a loading-unloading method. In this method the load is increased in steps while being unloaded between steps.

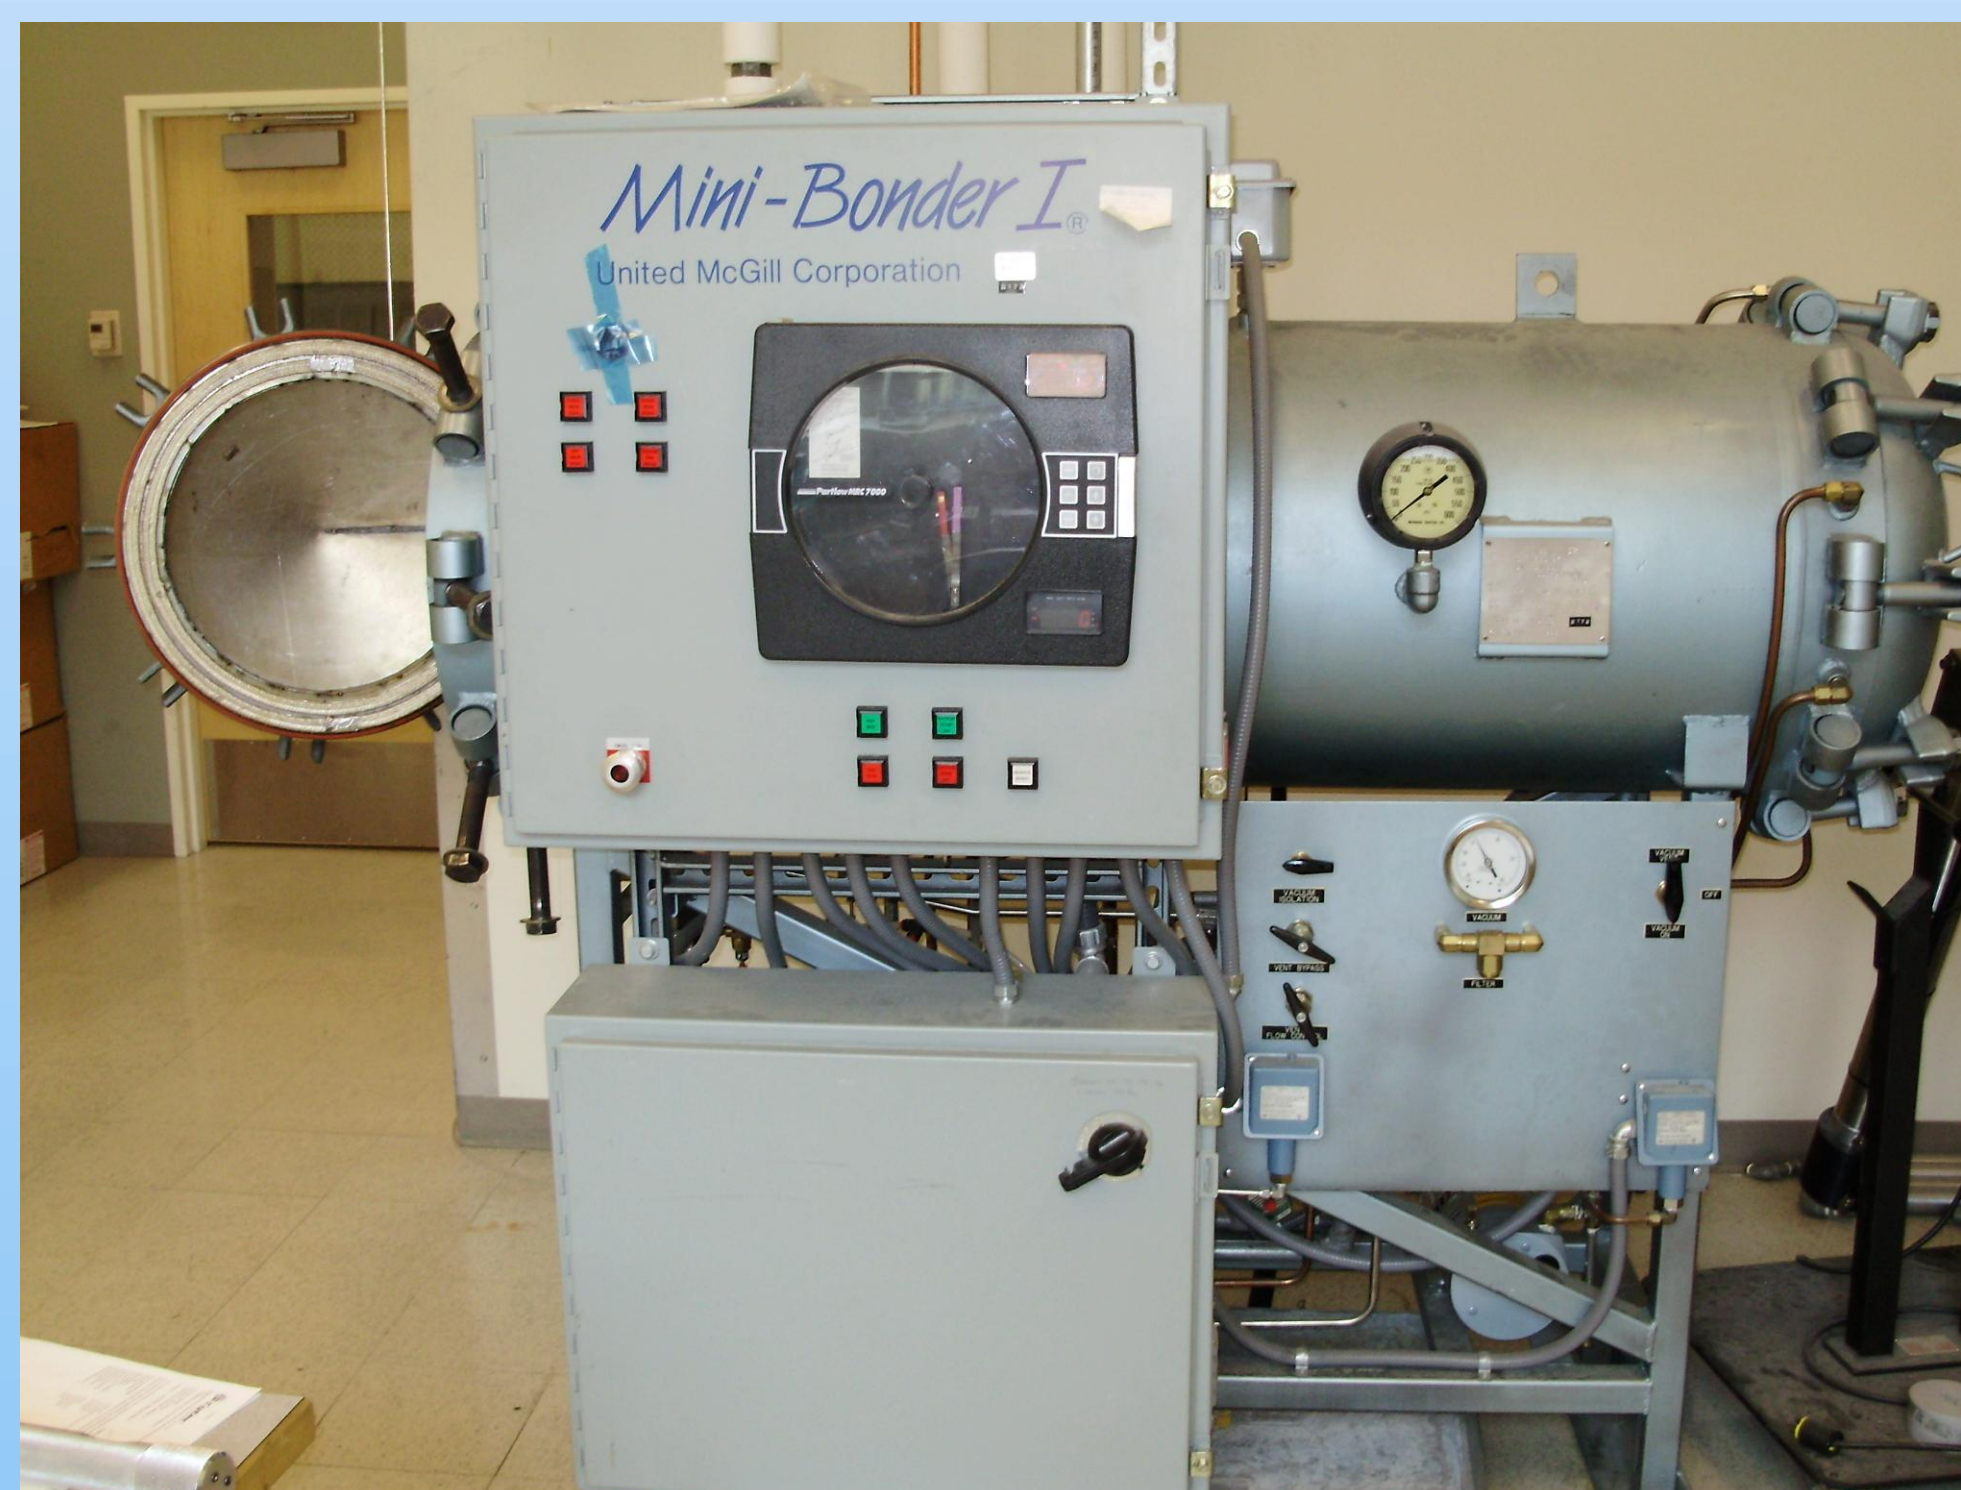
The Autoclave used to cure the composite plates

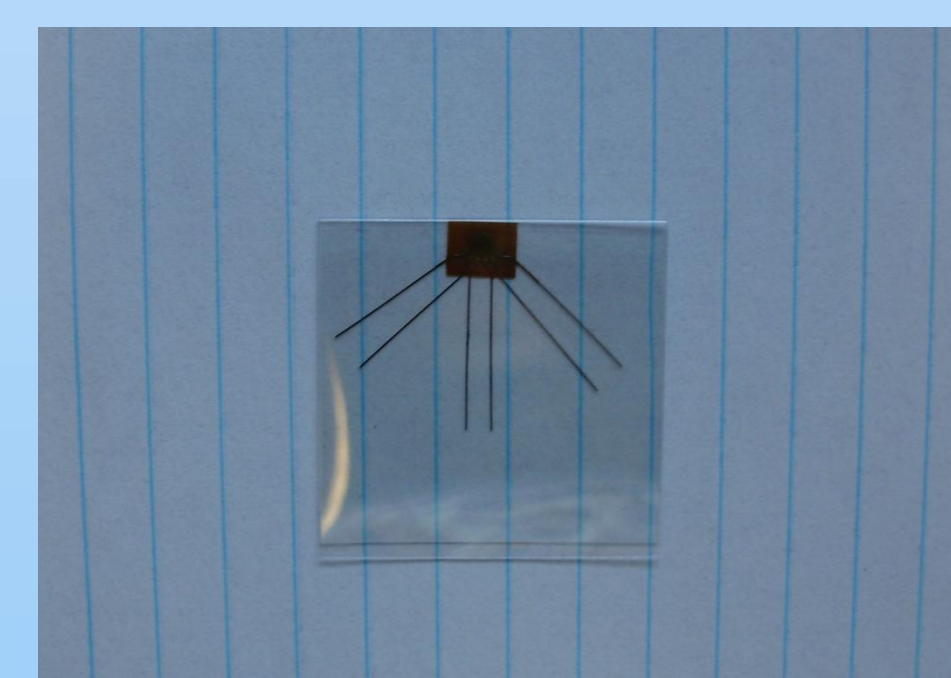
The Rosette Strain Gage

After being cured in the autoclave the sheets are then cut into coupons about two inches wide. Rosette strain gages and terminal strips are then glued to the coupons next to the hole. Rosette strain gages are actually three gages stacked on top of each other able to measure strain in the X, Y, and Z planes. Three sets of wires are soldered to the terminals and the coupon is ready for testing.

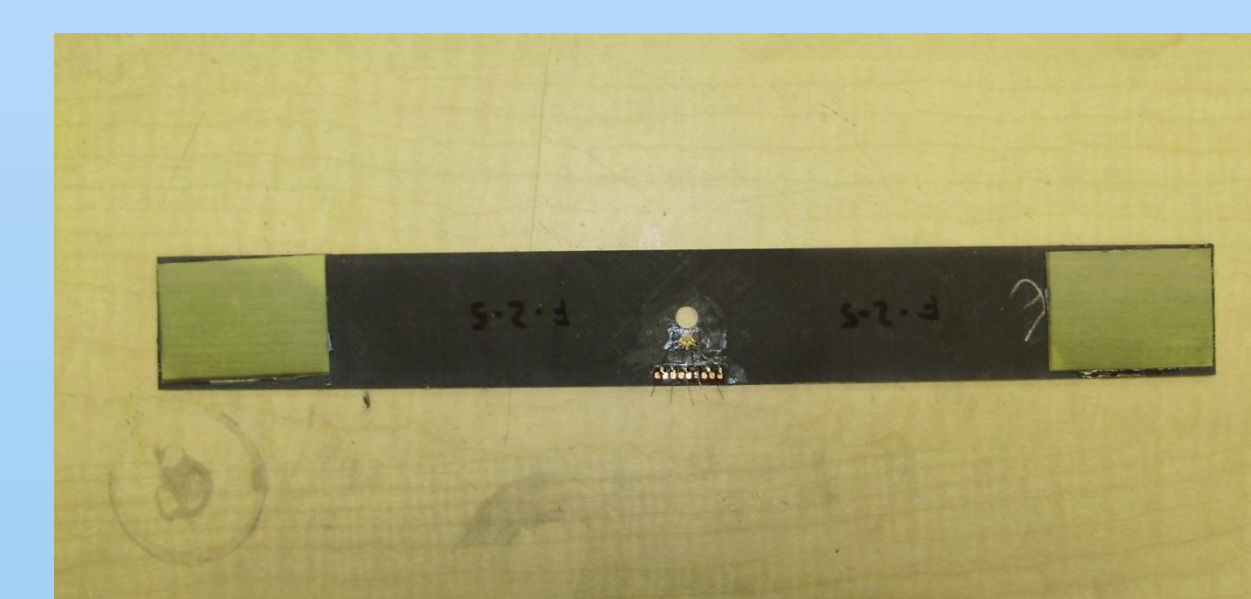
A coupon with strain gage attached

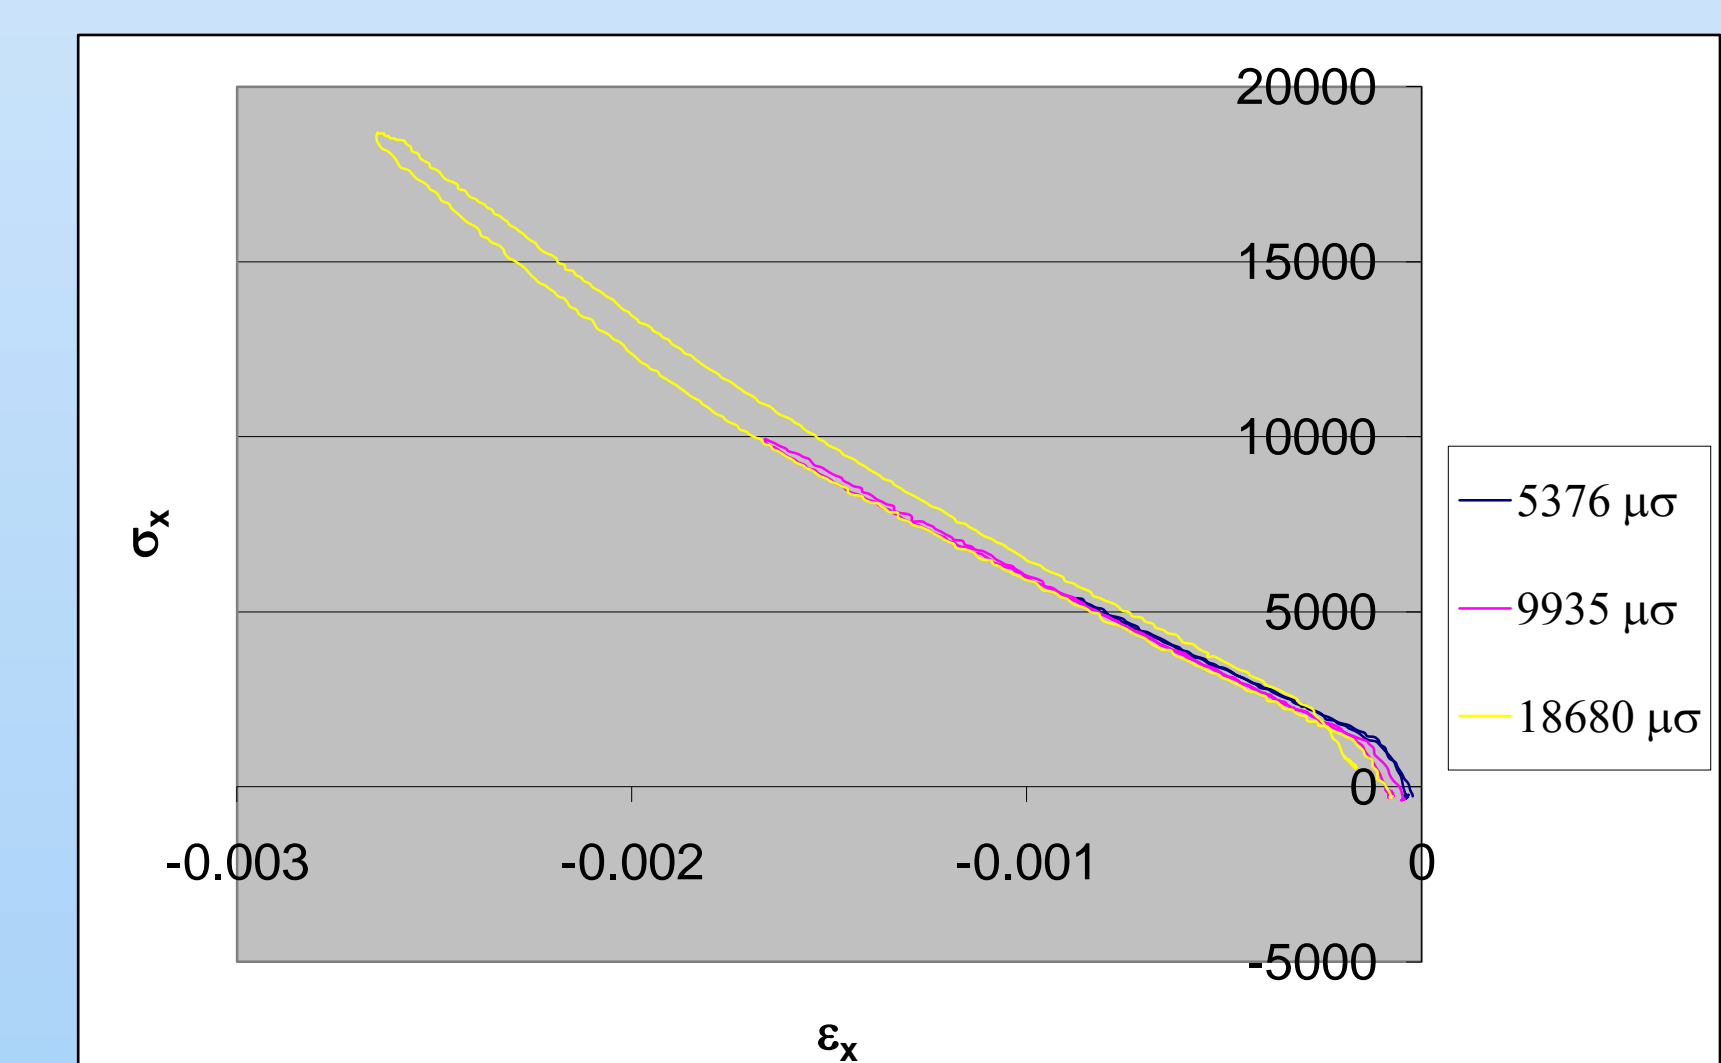
A pair of loading-unloading graphs from one of the coupons

Results were mixed between the five coupons tested. A couple of the coupons bent without breaking but had more than five percent strain. According to ASTM standards failure is defined as breaking of the outer fibers or more than five percent strain. Two more failed as expected having outer fiber failure. One coupon broke completely in half.
